Manhole Inspection Summary

Manhole # S51M__053MH

Insp Date: **4/8/08 1:18 PM**

Location Address: **2829 hudson st**

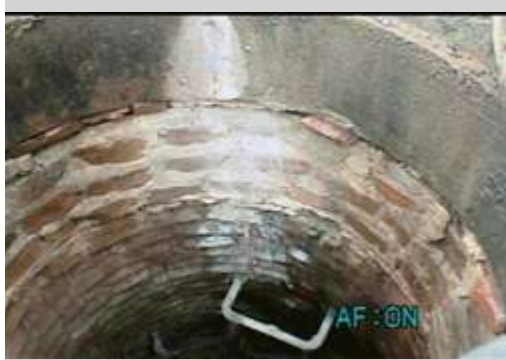
Defect 2

Condition: ☐ Sound ☐ Cracked ☐ Root Intrusion ☒ Loose Brick ☒ Deteriorated

chimney _loose bricks adjustment

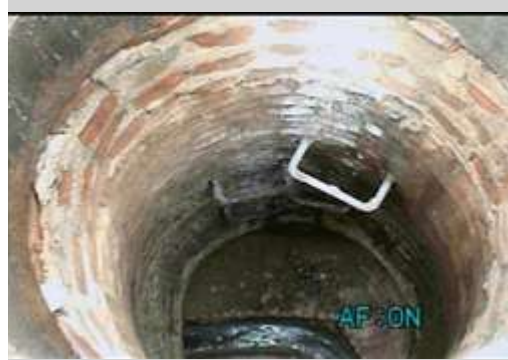
Defect 1

Steps Count: **5** Missing: **1** ☒ Corroded

corroded steps

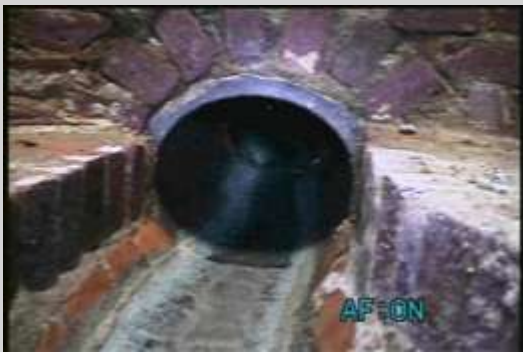
12 O'Clock Outflow

8 in. Circular Gravity Sewer
Pipe Out @ 12 O'Clock

Invert Depth: **10.80** (ft.) Flow Characteristics: **Fast**

Deposits: ☒ None ☐ Mud ☐ Sludge ☐ Debris ☐ Grease

Infiltration: **None** Pipe Seal Cond: **Unknown**

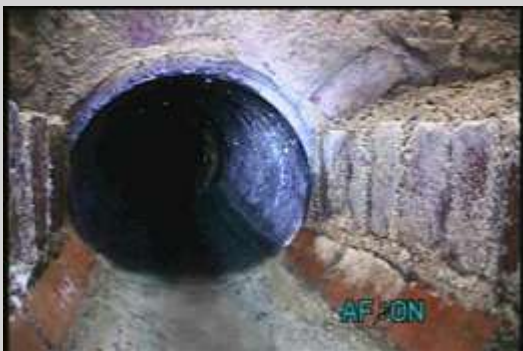
4 O'Clock Inflow

10 in. Circular Gravity Sewer
Pipe In @ 4 O'Clock

Invert Depth: **10.70** (ft.) Flow Characteristics: **Fast**

Deposits: ☒ None ☐ Mud ☐ Sludge ☐ Debris ☐ Grease

Infiltration: **None** Pipe Seal Cond: **Unknown**
